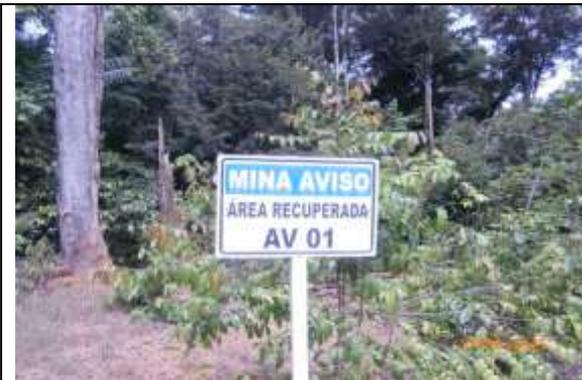
Placa de indicação da área recuperada

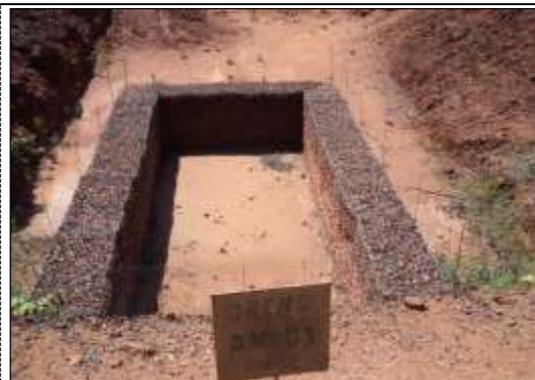
Filtro gabião com placa indicativa do Dreno AV 01

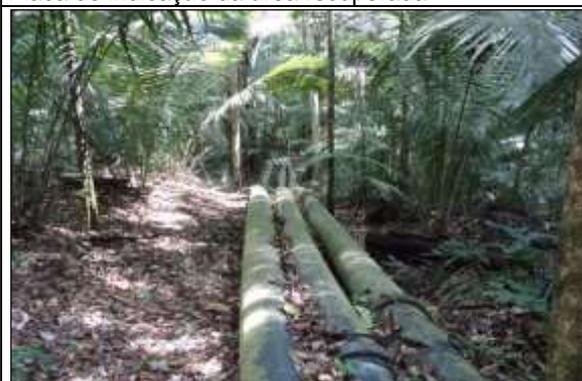
Tubulação de drenagem

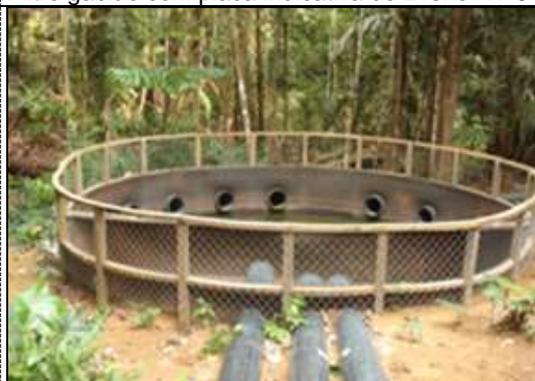
Caixa dissipadora de energia

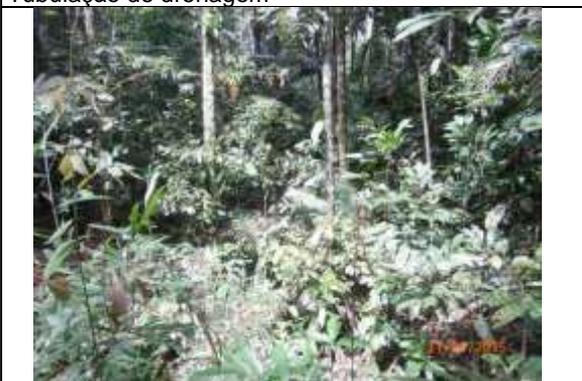
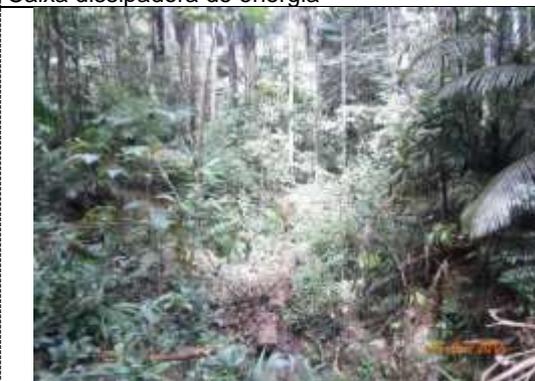
Presença de vegetação arbórea e ocorrência de regeneração natural e igarapé na área de baixo.

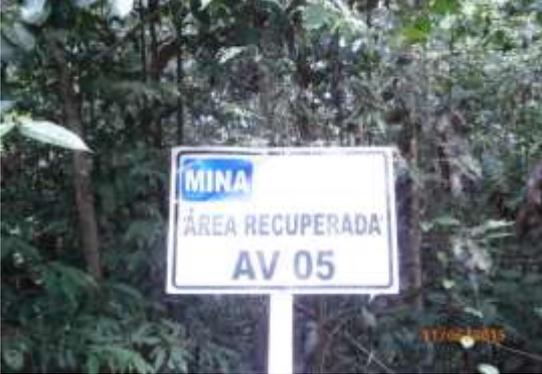
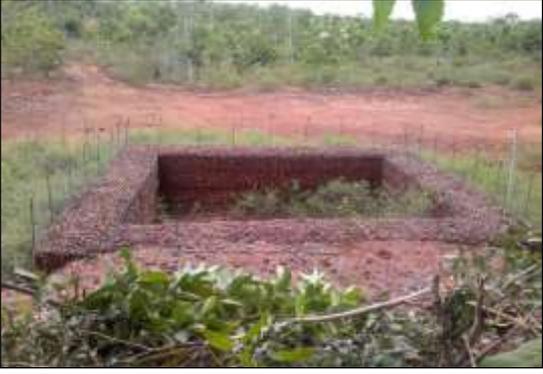
<p>A rectangular gabion filter structure made of wire mesh and filled with reddish-brown soil. It is situated on a flat, cleared area of red earth, with some green plants growing in front of it.</p>
<p>Placa indicativa da área recuperada</p>	<p>Filtro gabião instalado na borda no platô</p>

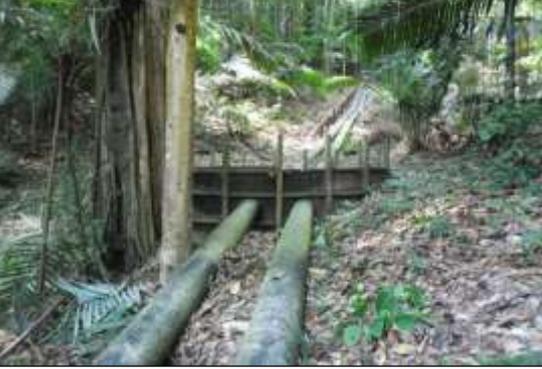
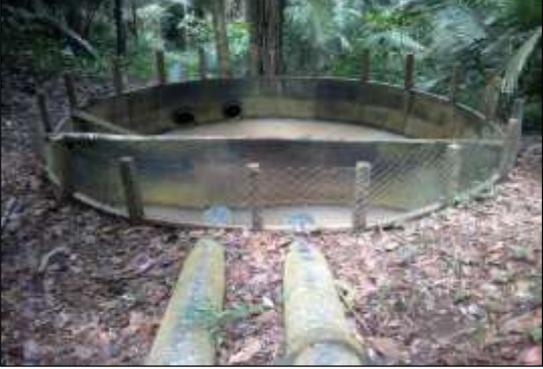
<p>Tubulação de drenagem</p>	<p>Dissipador de energia do fluxo hídrico</p>

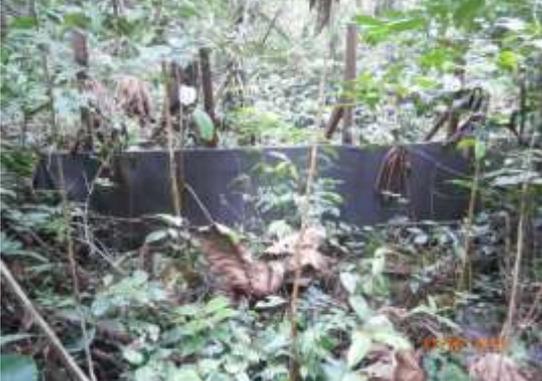
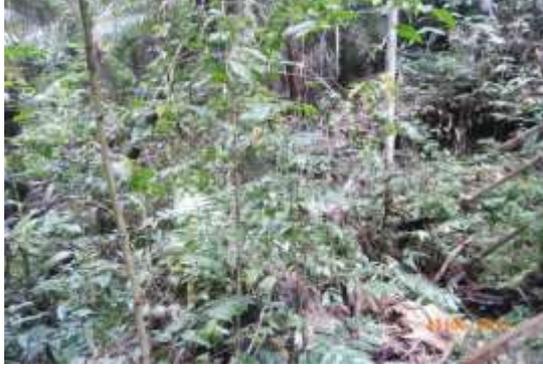
<p>A dense thicket of green plants and trees, showing the natural vegetation in the area.</p>
<p>Barragem tipo "castor" com presença de vegetação</p>	<p>Presença de vegetação</p>

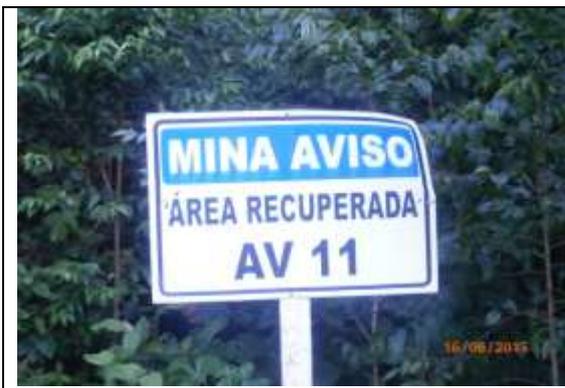
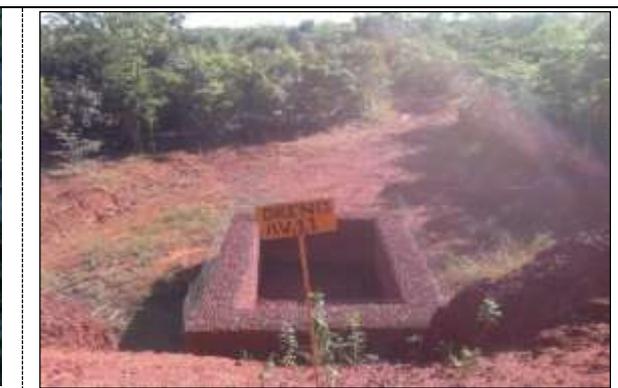
<p>A photograph showing a gabion filter structure, which is a rectangular frame filled with rocks, situated on a reddish-brown soil slope. The structure is partially covered with some vegetation. A small orange timestamp '16/08/2015' is visible in the bottom right corner of the photo.</p>
<p>Placa de identificação da área recuperada</p>	<p>Filtro tipo gabião na borda do platô</p>

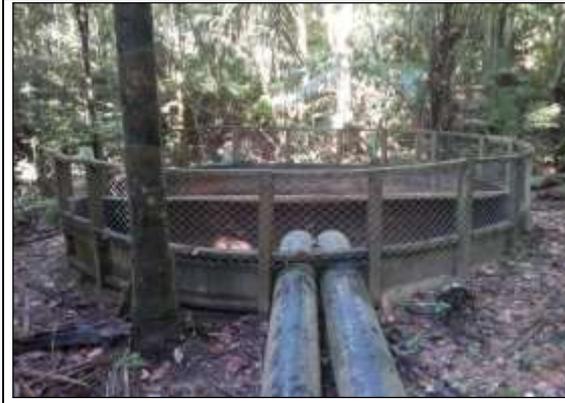
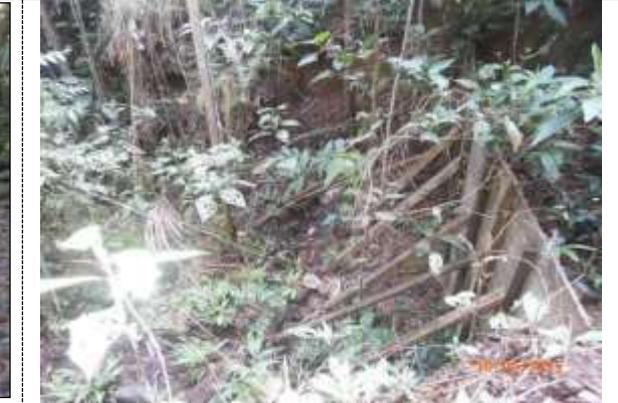
<p>Dissipador de energia do fluxo hídrico do sistema de drenagem</p>	<p>Barreira física tipo "castor" com presença de vegetação</p>

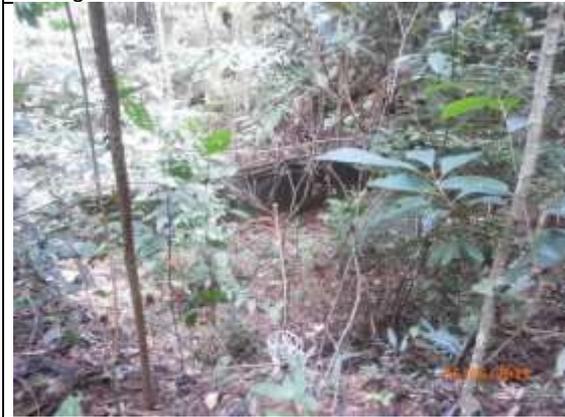
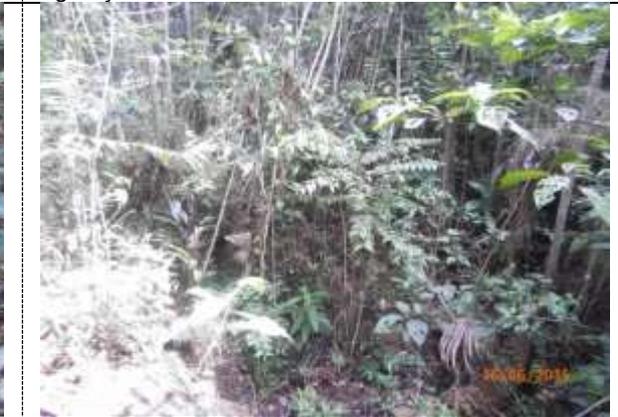
<p>A photograph showing a dense stand of medium-height vegetation, including various plants and tree trunks, situated in a wooded area. A small orange timestamp '16/08/2015' is visible in the bottom right corner of the photo.</p>
<p>Presença de vegetação na barreira física</p>	<p>Vegetação de porte médio</p>
