BW Offshore <i>Project:</i> FSU Belokamenka <i>Unit:</i> Ex. Berge Pioneer <i>Client:</i> Rosneft	<i>Document Family:</i> Reports	<i>No. of pages</i> 50
	<i>Document Title:</i> BELOKAMENKA INSPECTION REPORT.	
	<i>Doc. type:</i> RA - Technical Report <i>Discipline:</i> Z - Multidiscipline <i>Doc. No.:</i> 4022-RA-xxxxxxx	
		<i>Rev.</i> B

BELOKAMENKA INSPECTION REPORT.

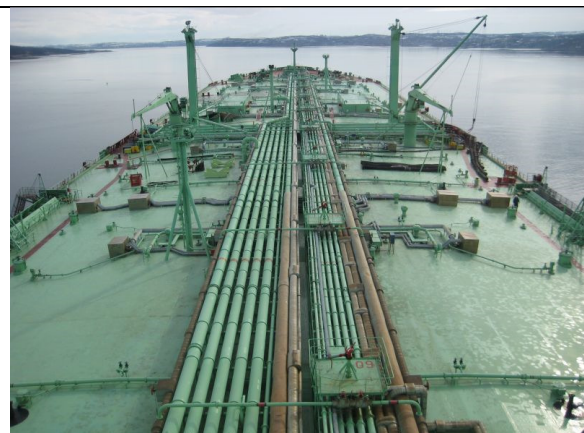
The main deck is in GOOD condition, there is little to no corrosion, the deck paint shows signs of regular maintenance. Deck plating, supports, pipes, tank domes, butterworth hatches are free from any signs of corrosion. It is noted that no fabric maintenance has been done for about a year, despite this fact, the overall condition is very good.

Deck Condition

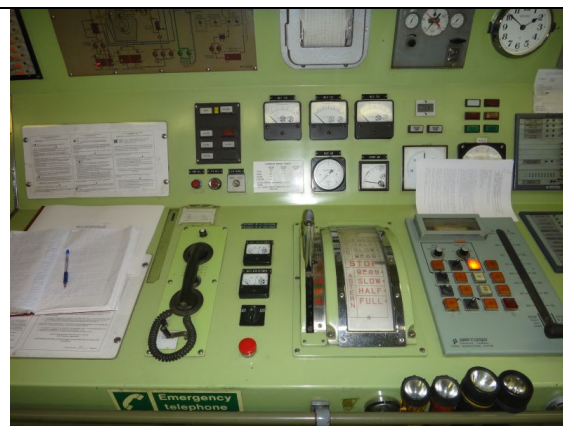
- The Main Engine Soeren T. Lyngsoe control and alarm system condition, a service visit is required to bring the system back in operational condition.
- The Main Engine critical spares condition needs to be confirmed, it is recommended having a complete set of overhauled spares available for the journey – complete piston with piston rod, piston crown, skirt and stuffing box, fuel pump plunger/barrel, complete cylinder cover with exhaust valve and fuel and starting air valve, a complete cylinder liner with cooling jacket in confirmed good condition. There is an overhauled cylinder cover with exhaust valve and there is what appear to be a new cylinder liner. There is no complete overhauled piston assembled.

Main Engine control system

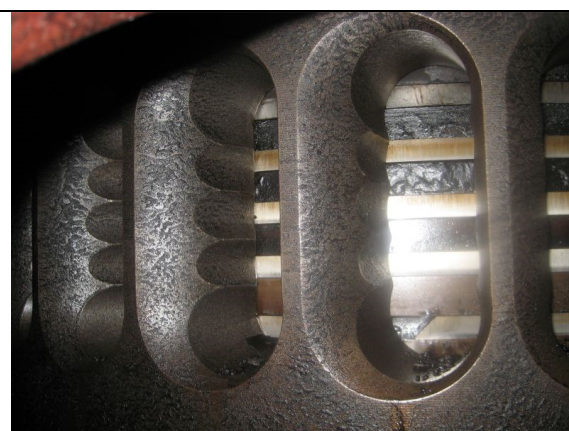
- The Main Engine needs full commissioning, and is to be inspected to the satisfaction of a DNV Surveyor Memoranda 94. Mechanically the main engine appear to be in good condition. A port inspection was carried out which revealed a broken top ring on Cylinder No. 12 and a few minor issues. As a minimum cylinder 12 must be pulled, overhauled and rings replaced. The crankcase and camshaft of the main engine were also inspected and found in very good condition.

Main engine Cyl 12 broken top ring

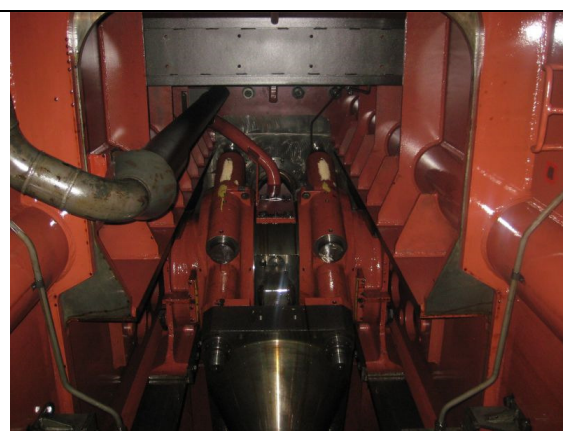
Main engine crankcase condition

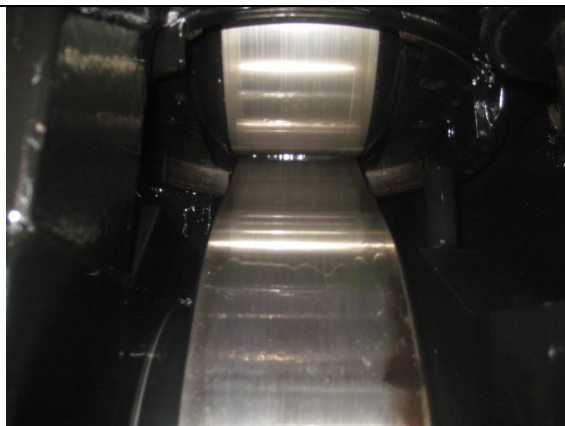
Main Engine Camshaft and roller guide condition

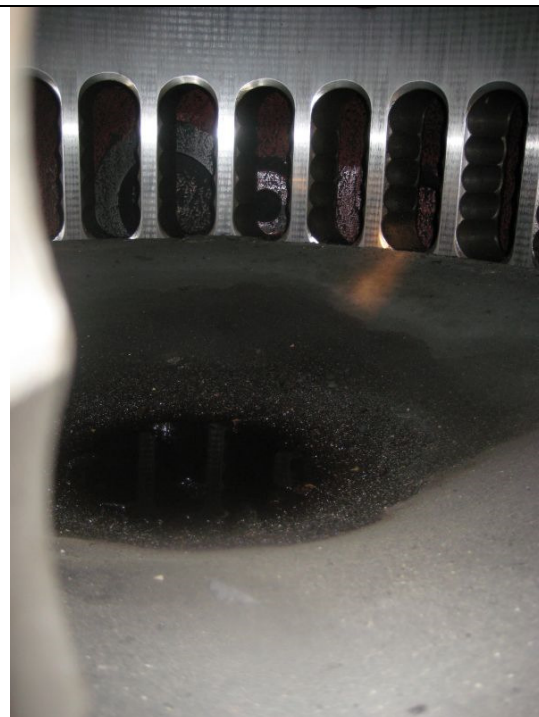
- There was small puddles of fuel oil on top of several pistons, during the port inspection all fuel oil inlet valves were closed. Once the fuel system has been commissioned, a port inspection must be made to determine any leaking from the fuel oil valves.

Fuel oil present on top of piston crowns on several cylinder units

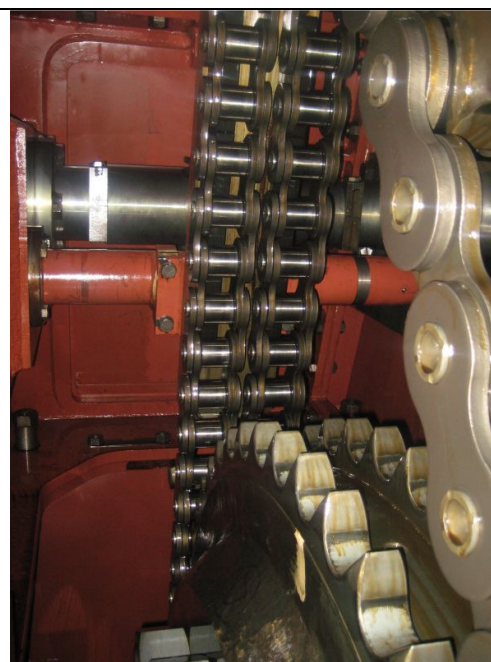
Main engine chain condition

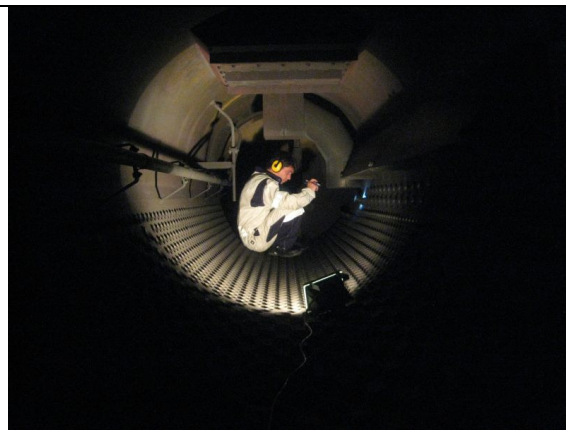
- The Main ships boilers needs minimal refractory work done on the plugged tube facing the furnace. Only STBD boiler was inspected, but Port boiler has similar plugged tube and condition expected the same. The refractory cones at the burners needs to be repaired as well. The internal soot layer needs to be removed.

Boiler Inspection

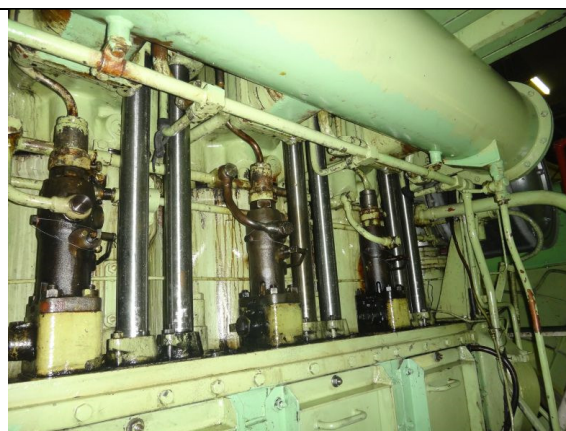
- Ships anchors needs to be installed for both anchor winches. The current anchors are for permanent mooring only.
- Aft Diesel Generator has an emergency repair done on fuel inlet pipe for Cyl#5, this needs replacement.

Aft Aux. Eng. Cyl#5 FO inlet line temp repair

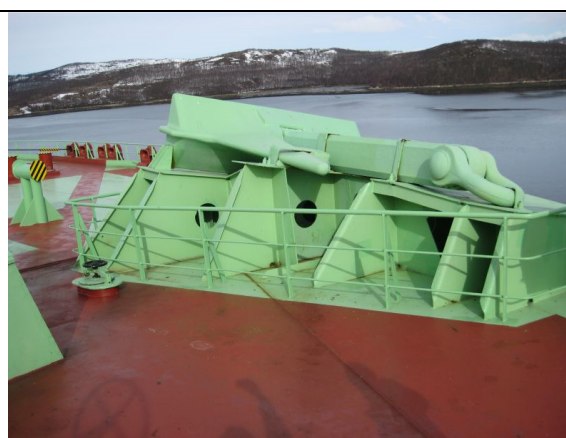
Vessel is fitted with two (2) off anchors, two anchor chains, a number of windlasses. All equipment is reported to be in working condition and has been well maintained. The Port and Starboard anchor was deployed at site, the original anchors have been replaced in order to accommodate mooring at site. There is an original type spare anchor on the bow port side area – this appear in excellent condition.

Spare Anchor on bow
