BW Offshore <i>Project:</i> FSU Belokamenka <i>Unit:</i> Ex. Berge Pioneer <i>Client:</i> Rosneft	<i>Document Family:</i> Reports	<i>No. of pages</i> 50
	<i>Document Title:</i> BELOKAMENKA INSPECTION REPORT.	
	<i>Doc. type:</i> RA - Technical Report <i>Discipline:</i> Z - Multidiscipline <i>Doc. No.:</i> 4022-RA-xxxxxxx	
		<i>Rev.</i> B

BELOKAMENKA INSPECTION REPORT.

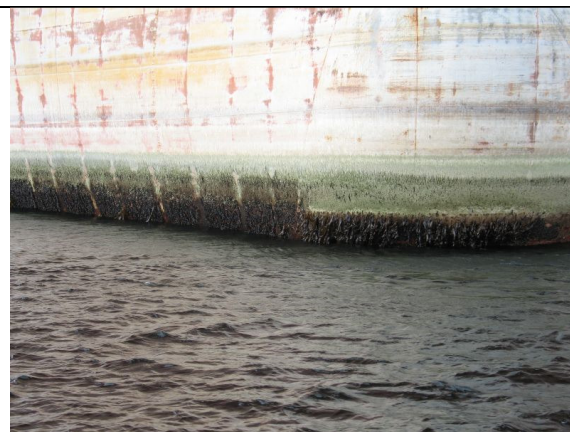
Marine Growth

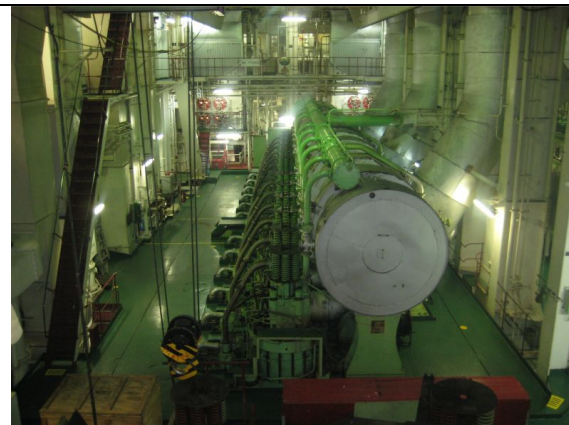
Main engine, engine room

- The Main Engine needs full commissioning, and is to be inspected to the satisfaction of a DNV Surveyor Memoranda 94. Mechanically the main engine appear to be in good condition. A port inspection was carried out which revealed a broken top ring on Cylinder No. 12 and a few minor issues. As a minimum cylinder 12 must be pulled, overhauled and rings replaced. The crankcase and camshaft of the main engine were also inspected and found in very good condition.
